**SETTLEMENT MONITORING
NKU FOUNDATION PROPERTY
DIXIE HIGHWAY & MT. ALLEN ROAD
COVINGTON, KENTUCKY**

**NKU FOUNDATION, INC.
HIGHLAND HEIGHTS, KENTUCKY**

**THELEN ASSOCIATES,
A DIVISION OF GEOTECHNOLOGY, INC.
ERLANGER, KENTUCKY**

JULY 11, 2016

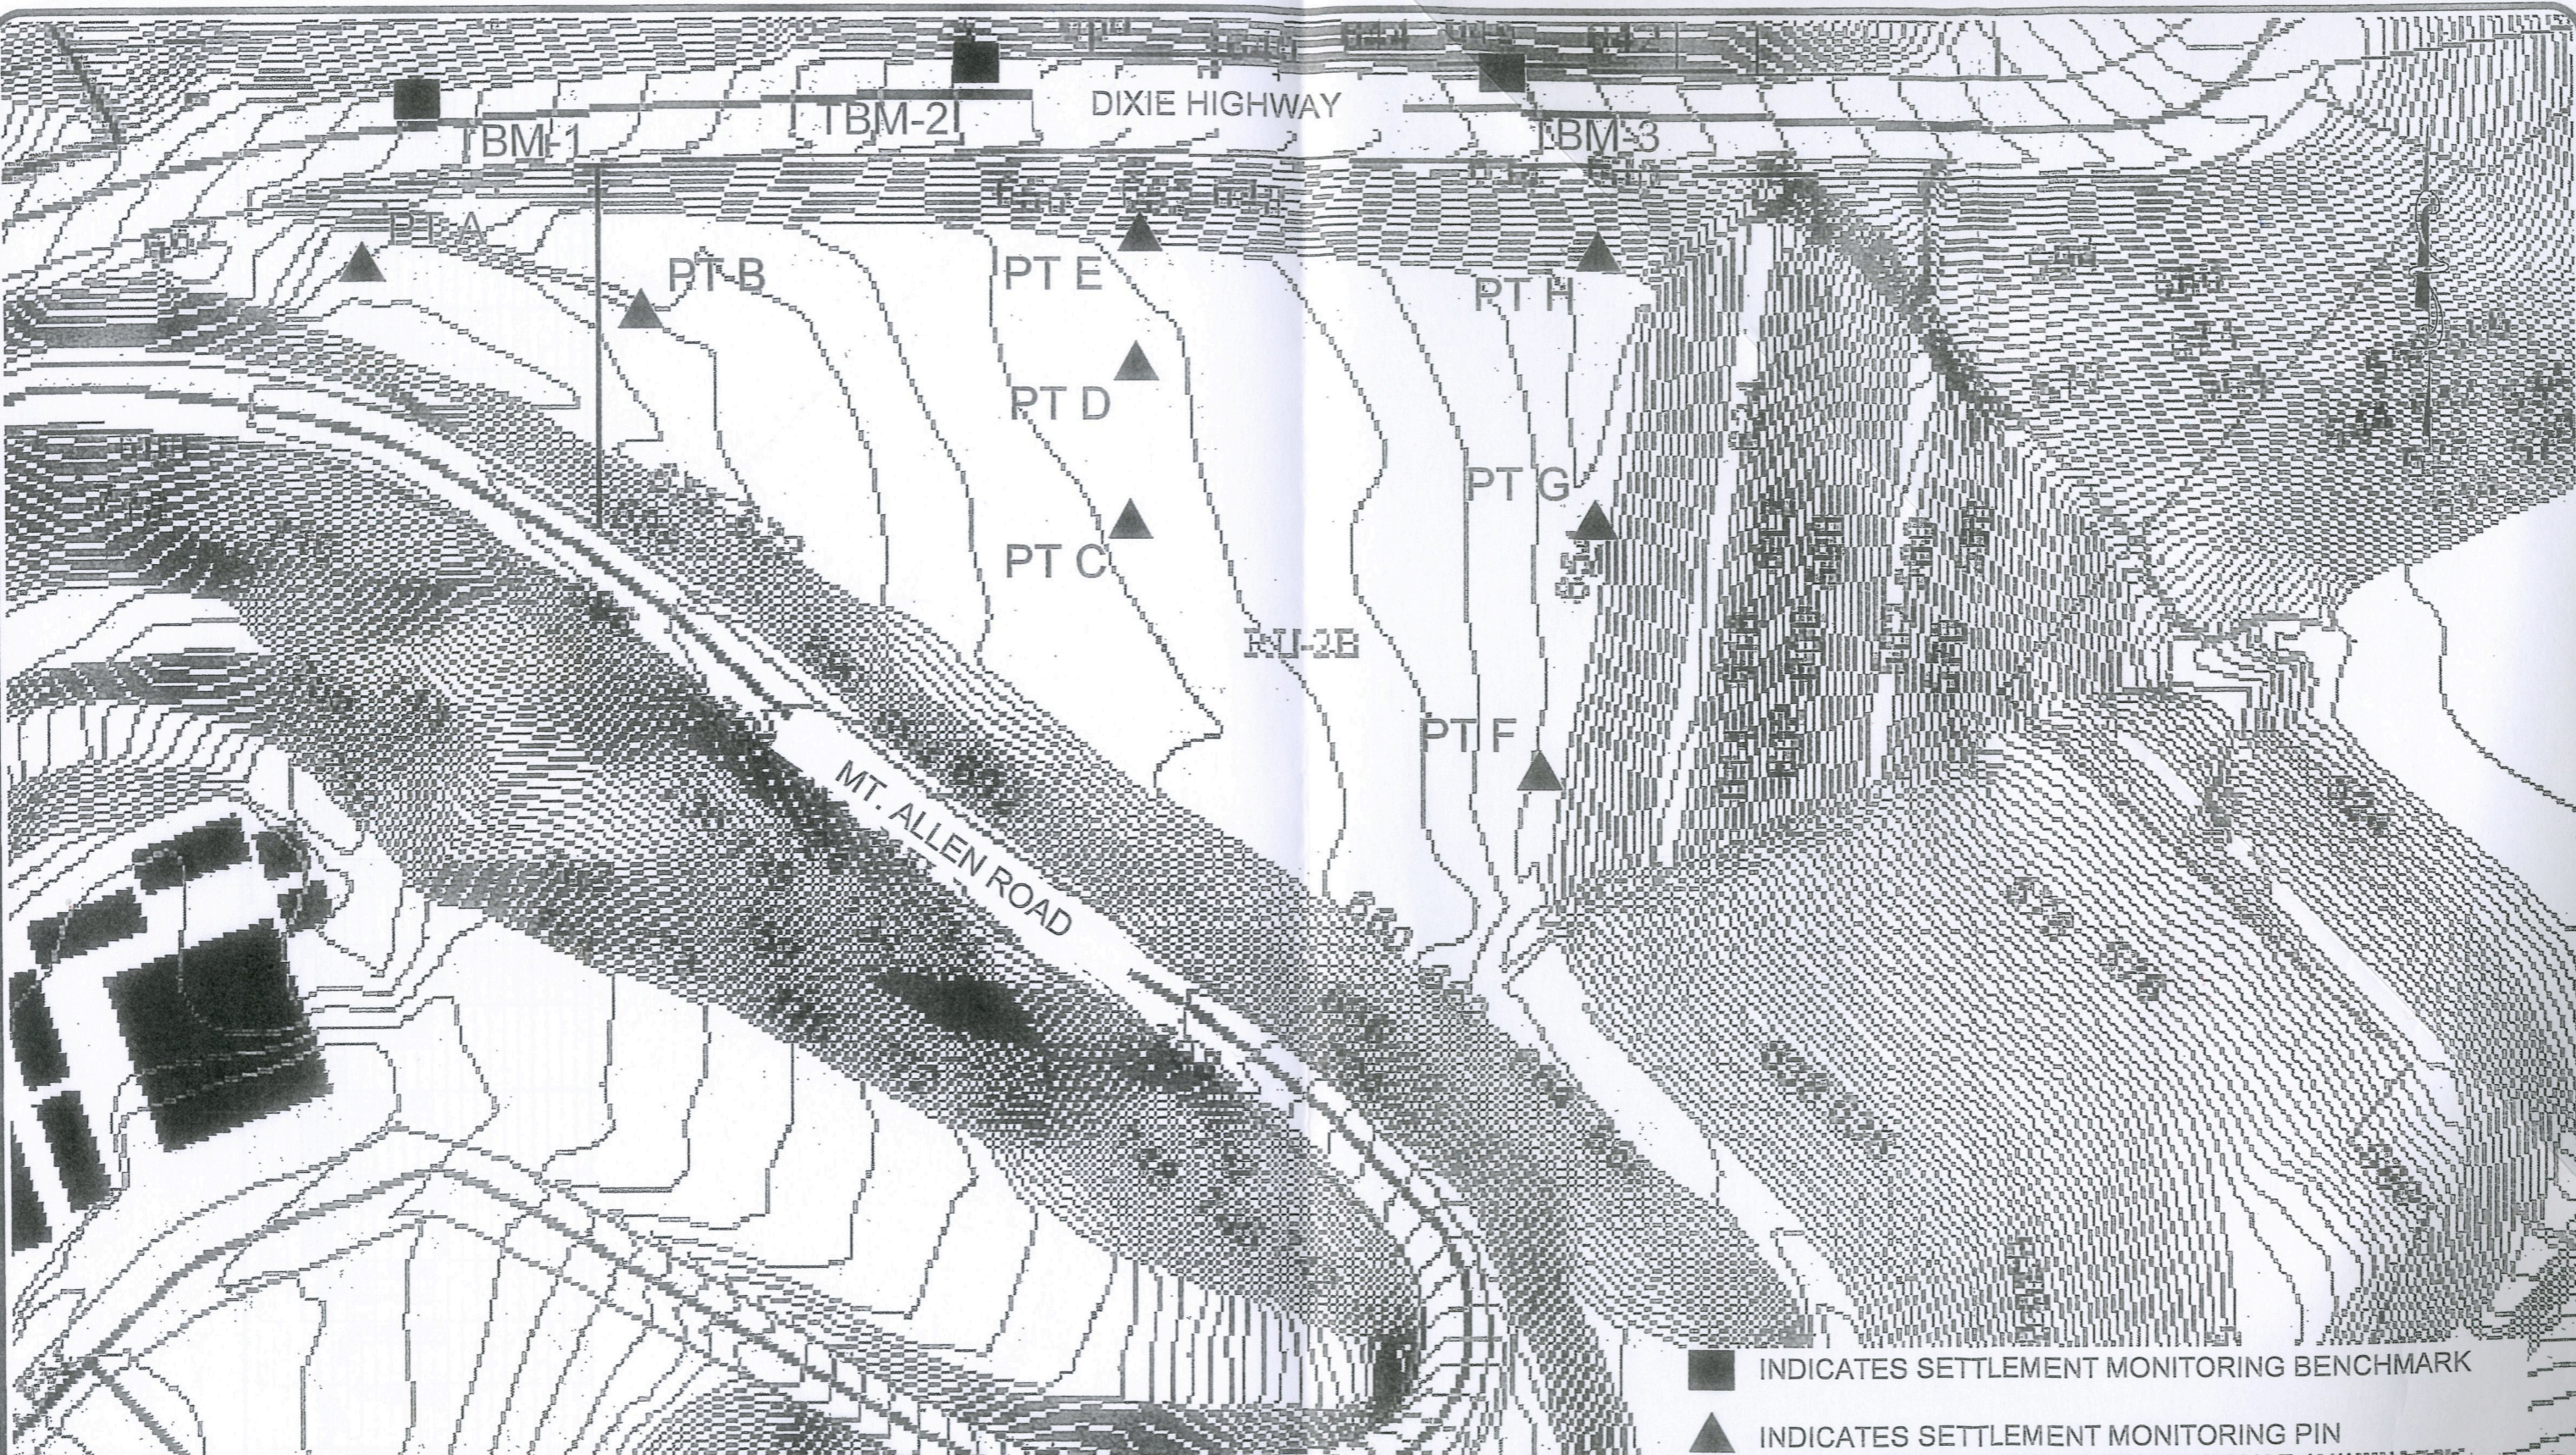
Title: MONITORING PLAN

unable to be surveyed as it appears that since the pins were last read in December 2009, there has been some dumping on the property and Pin A was buried. We also note that one of the benchmarks (TBM-3) was damaged after the February 2008 reading. The locations of all of the benchmarks (numbered TBM-1, 2 and 3) and the settlement monuments (lettered PT-A through PT-H) are shown on the attached Monitoring Plan, Drawing 94821E-1.

We recommend that the existing settlement pins and benchmarks be left in place for future monitoring. The survey can be repeated with time and the data added to the existing data to further assess the time rate and location of consolidation ongoing. We suggest as a minimum that the existing settlement pins be surveyed on an annual basis as long as the NKUF owns the property. If you elect to build on the property, we recommend that we be retained to consult early during the planning and design phases.

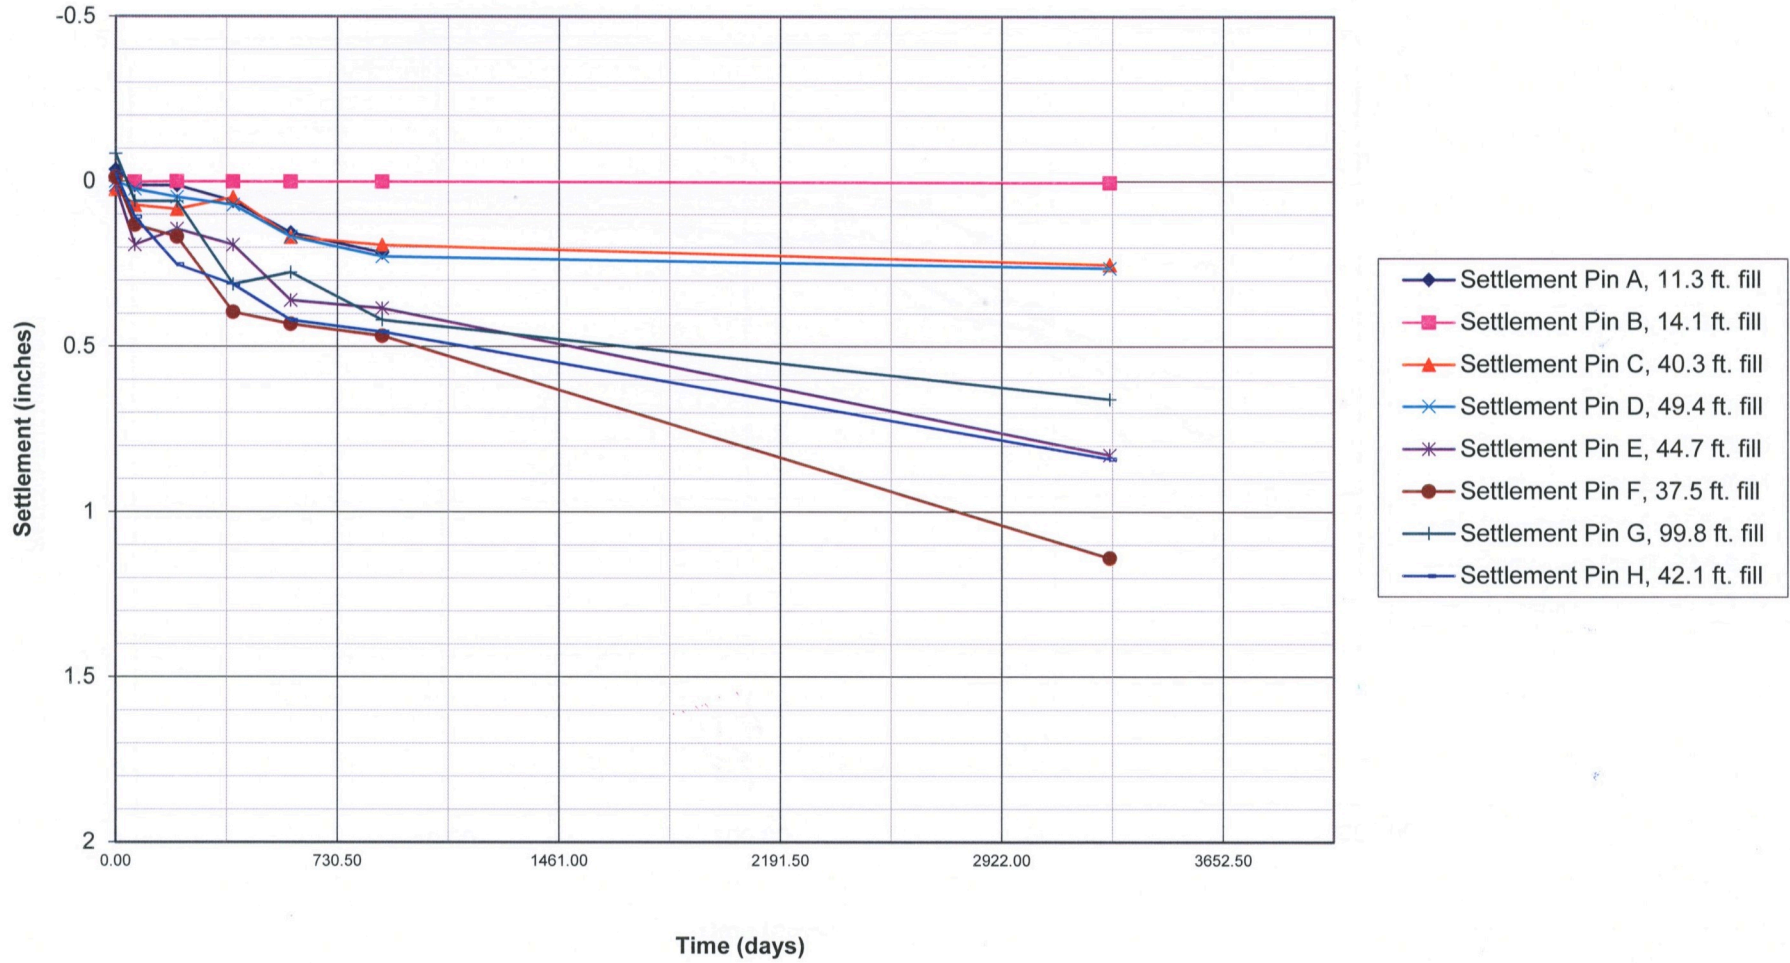
Settlement Vs. Time

The data from the settlement monitoring program is tabulated on the attached two settlement tabulation sheets included herewith, and are graphically illustrated on the two attached settlement graphs. There is some minor variability in the data as a result of the equipment and human limitations. Looking at the data collectively, there is reasonable correlation and some clear trends. Settlement Pin B, which was estimated to be on a fill embankment of only approximately 14 feet in depth, showed no signs of settlement over the 9-year monitoring period as one would expect.

Settlement Pins C, D, E, F and H included estimated fill thicknesses of 37 to 49 feet and showed a settlement range of approximately $\frac{1}{4}$ to $1 \frac{1}{8}$ inches over the 9-year monitoring period. The trends of each of those monitoring pins is continued settlement at a recent rate of approximately $\frac{1}{32}$ to slightly less than $\frac{3}{16}$ inch per year. Settlement Pin G was located near the crest of the fill slope near the alignment of the original valley where there was an estimated 100 feet of fill. That settlement pin settled approximately 0.66 inches over the past 9 years and at a rate within the range defined above.

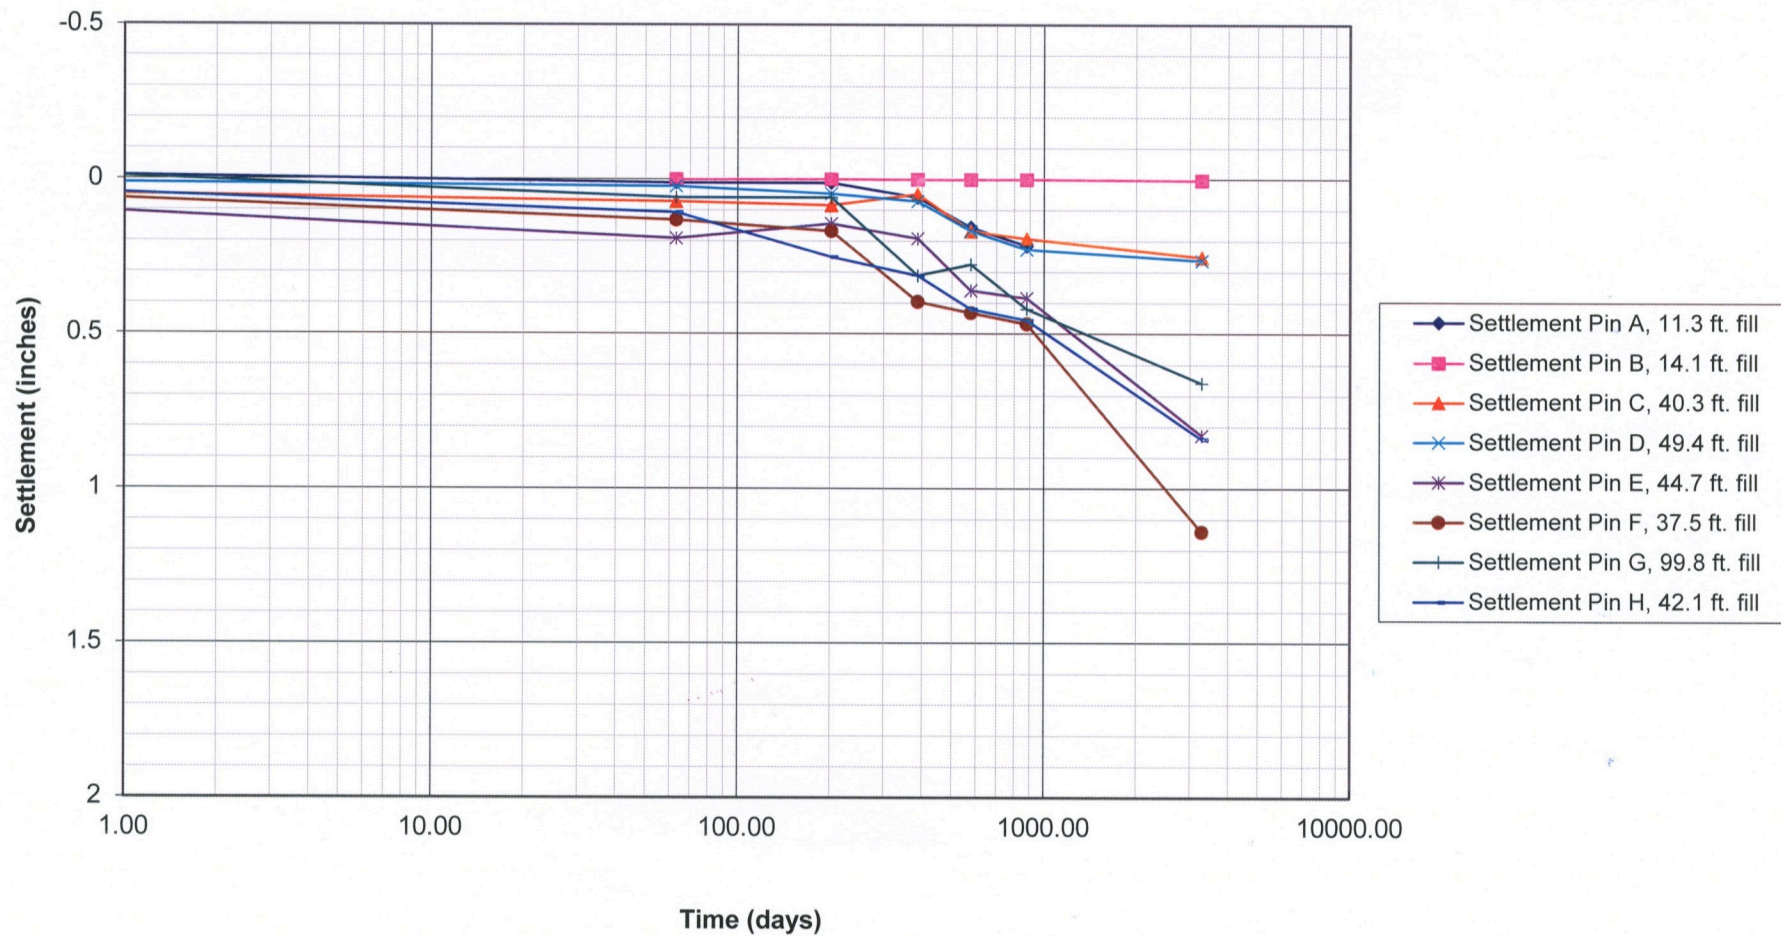
Settlement Vs. Log of Time

Theory of consolidation indicates that the rate of settlement decreases with the progression of time such that there is a point in time at which the amount of settlement is within tolerable amounts, and the embankment can be considered to have "settled out". The degree to which the settled-out process has occurred is, in part, a function of the tolerance for future settlements, depending upon whatever would possibly be constructed upon the fill. Most structures have a tolerance level estimated at approximately 1 inch of differential settlement.
